# Test deployment of the $4\pi$ instrumentation unit

Fred Gray – University of California, Berkeley  
KamLAND collaboration meeting, Gatlinburg, TN – April 2-4, 2005

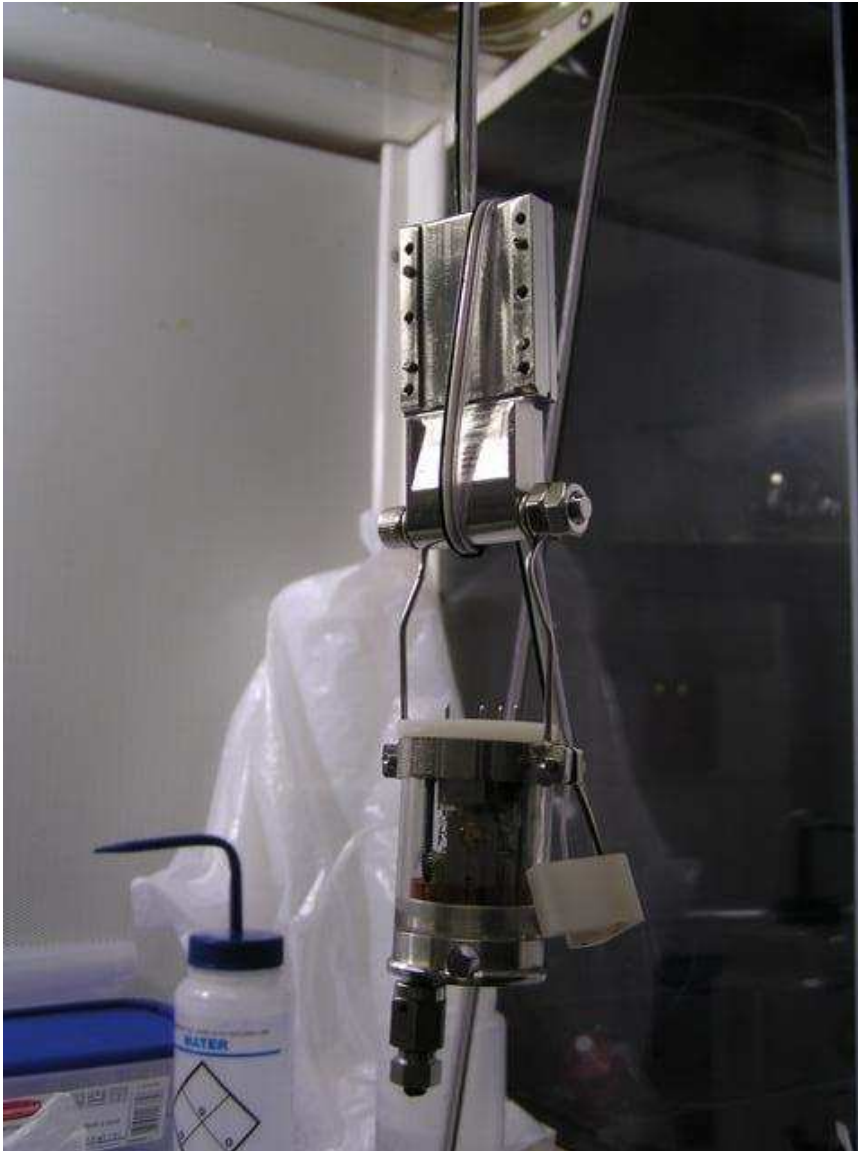
# *Instrumentation unit*

- ▶ Pressure sensor
  - ▶ Thermometer
  - ▶ Three-axis accelerometer
  - ▶ Two IR LEDs (830 nm)
- 
- ▶ Deployed to a depth of 18 m below the bottom of the glove-box in 1 m steps

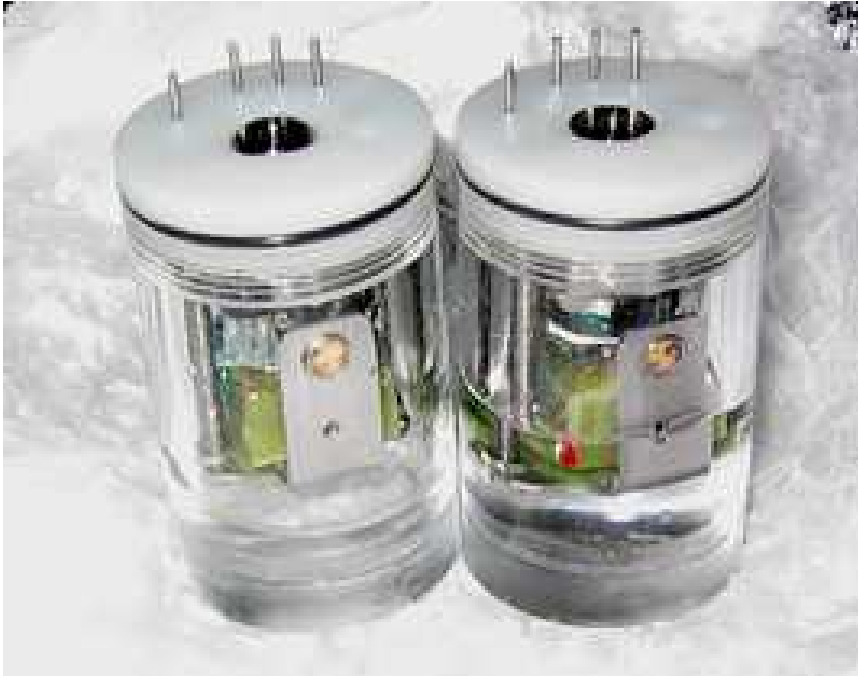
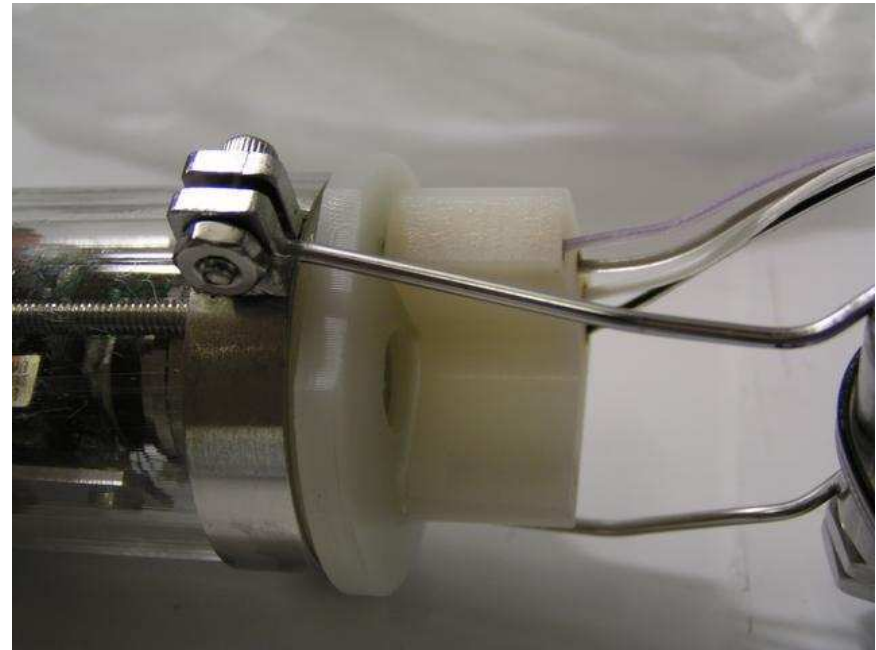
## *Two early lessons*

- ▶ Pressure test failure (January 2005)
- ▶ Connector thumbscrew mismatch

- ▶ Lucite enclosure made pressure-tight
- ▶ Problem with connector thumbscrew fixed
- ▶ Need for reference sensor in glovebox established
- ▶ Need for temperature correction established
- ▶ ...and, we found that the instrumentation unit basically works!

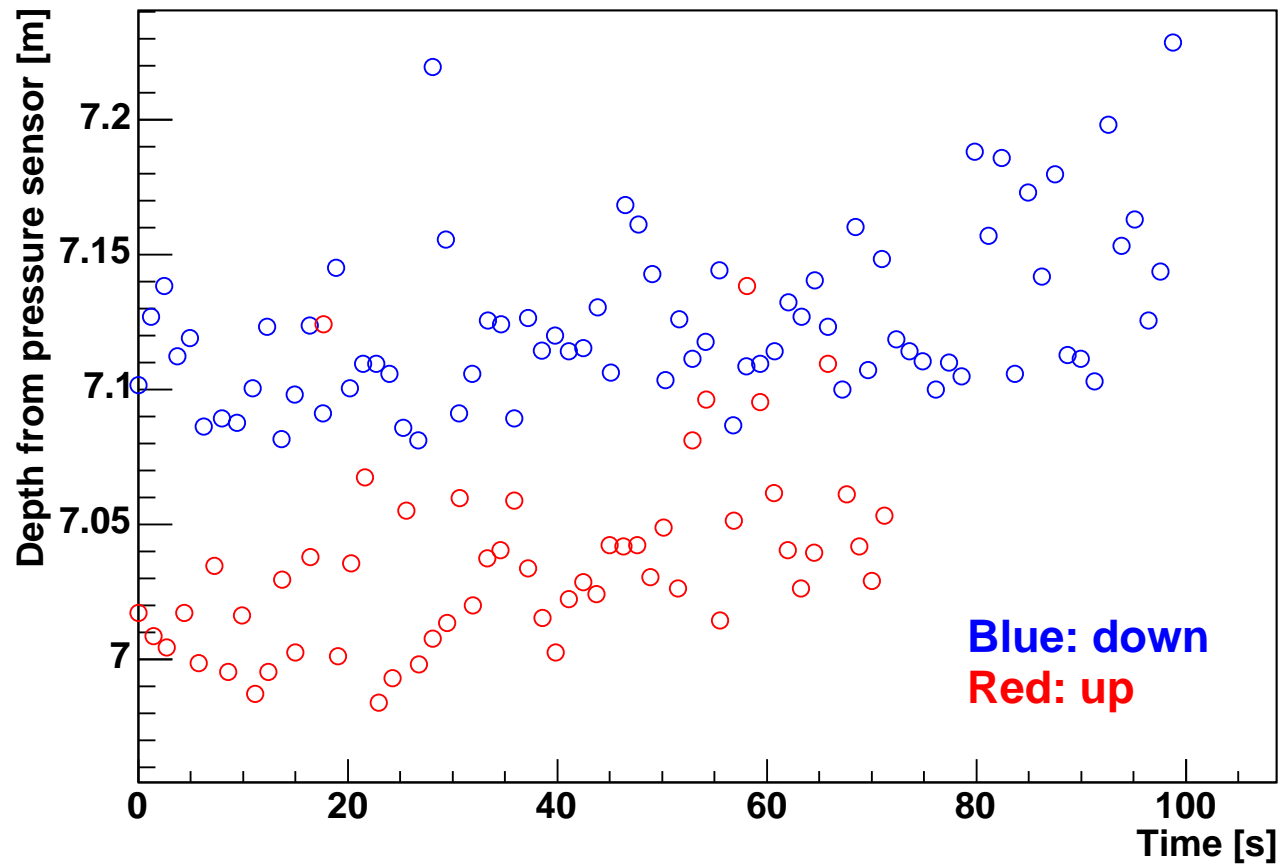
# Pressure sensor resolution

- ▶ RMS of single measurement  $\simeq 4$  cm
- ▶ 1 measurement per second; 0.5 cm in one minute

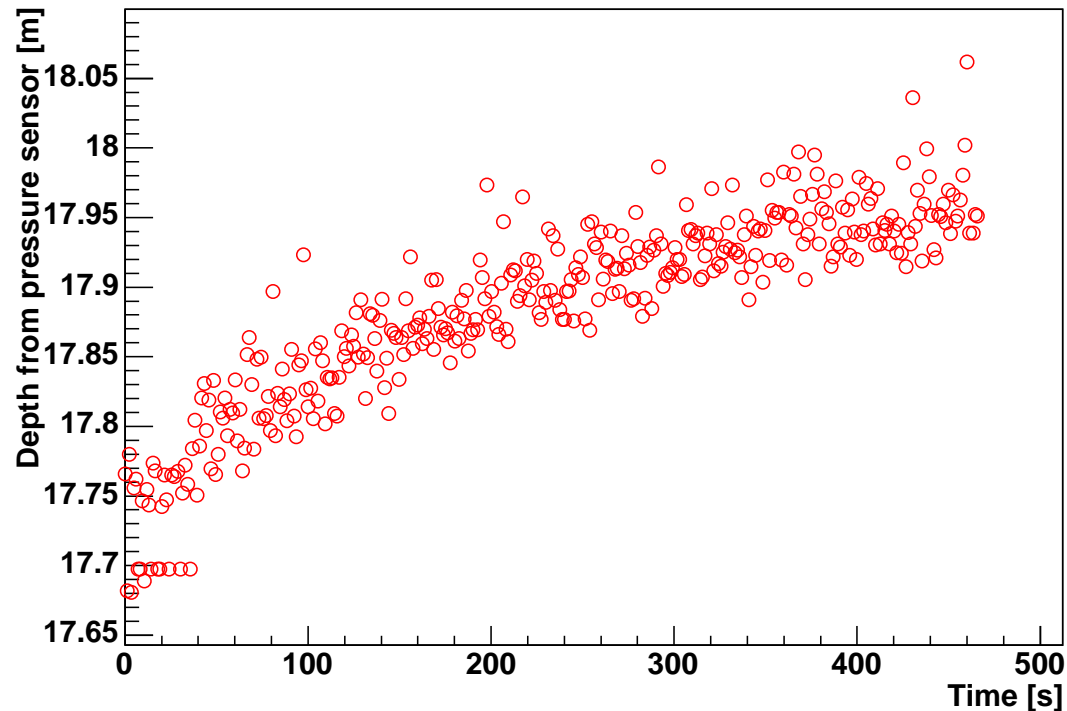
# *Pressure fluctuations from glovebox*

- ▶ Instantaneous “spike” followed by slow recovery to atmospheric pressure through glovebox leak.
- ▶ Need reference pressure sensor in glovebox.
